# Home Inspection Report

89 Pool Pl  
Staten Island, NY 10303

# P & D Home Inspections

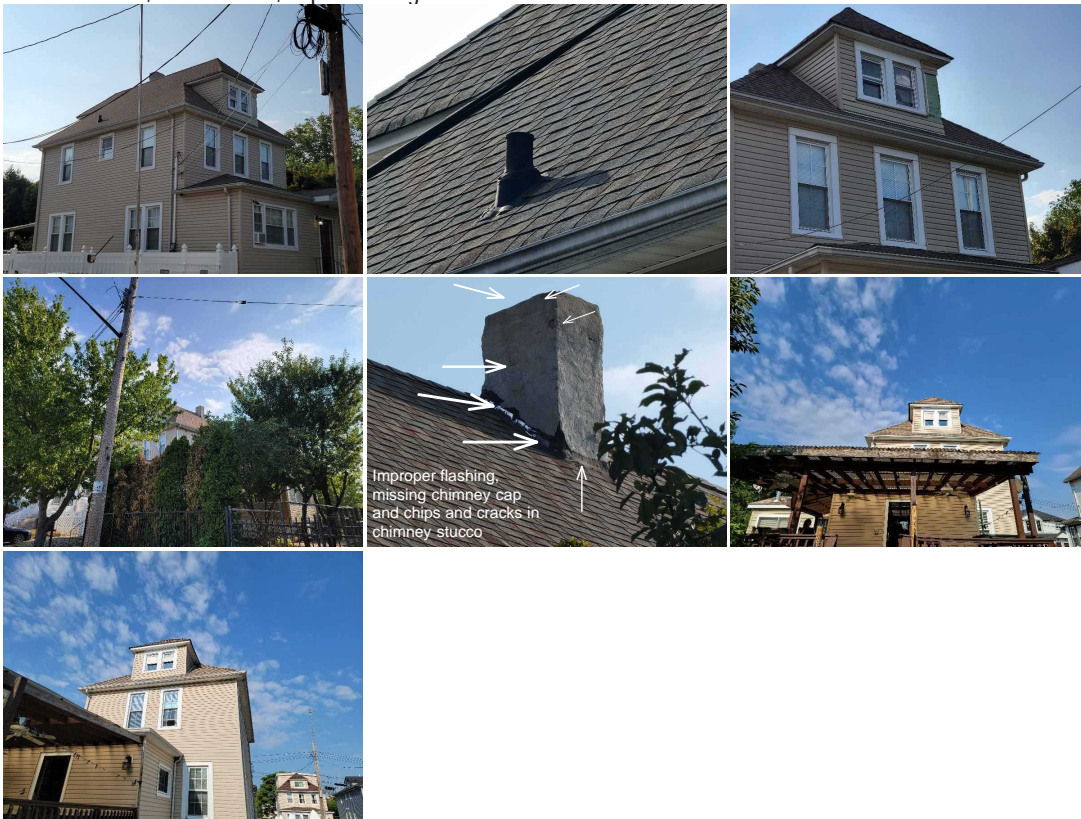
4. Type: Hip, Shed
  5. Approximate Age: 5 yrs-10 Yrs
  6. Functional, Marginal, Monitor Flashing: Tar, Aluminum - The flashing around the chimney appears to be aluminum covered over with tar. This is a sloppy and improper installation which can cause water to penetrate into the home. It's recommended that a licensed Roofing contractor be contacted for evaluation and repair.

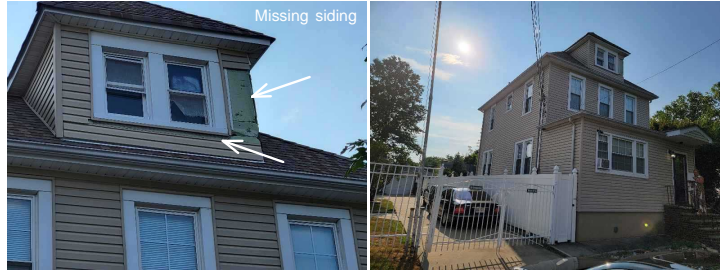
1. Functional, Maintenance Item Type: Vinyl siding - During the inspection it was noted that the right corner of the attic dormer is missing approximately 4 sections of siding. It's recommended that a licensed contractor be contacted for repair/replacement of those missing sections.

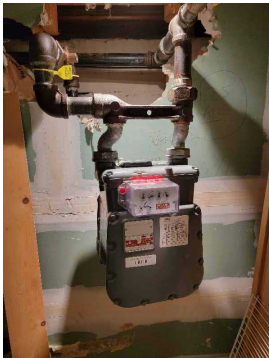
12. Functional Gas Meter: Basement - Main shut off valve at meter located in basement

13. Functional Main Gas Valve: Located at gas meter

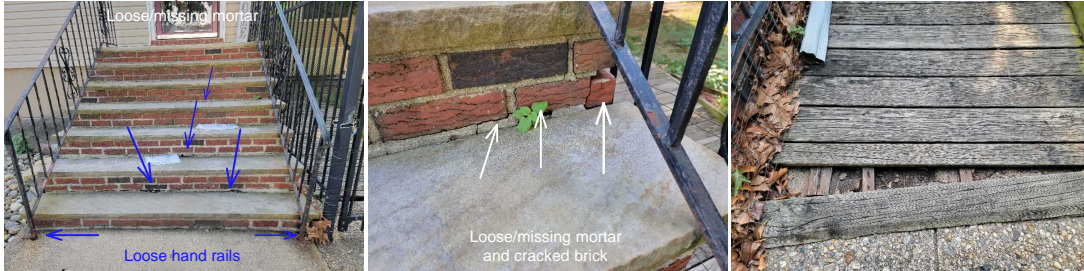
3. Functional, Defective Steps: Brick, Limestone Tread - At the bottom of the front steps, the handrails are loose. There is also loose and missing mortar to some of the treads. A cracked brick was also noted. It's recommended that a licensed Masonry contractor be contacted for evaluation and repair.

1. Steps: Brick, Limestone Tread - At the bottom of the front steps, the handrails are loose. There is also loose and missing mortar to some of the treads. A cracked brick was also noted. It's recommended that a licensed Masonry contractor be contacted for evaluation and repair.

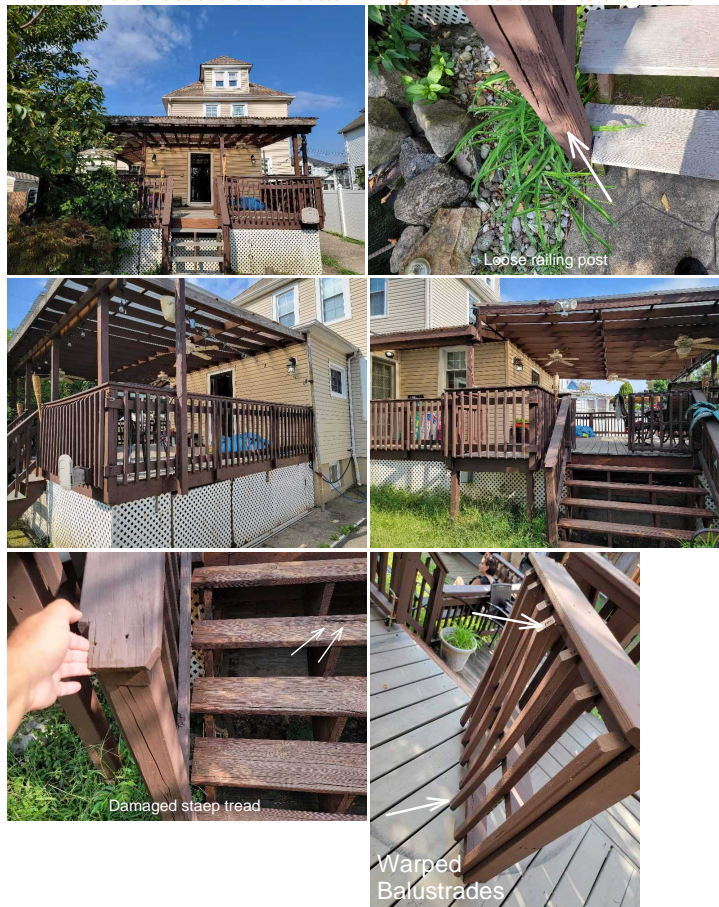
6. Functional, Marginal, Defective, Maintenance Item Deck: Pressure Treated Lumber - Due to age of deck and construction methods of the time, nails were used to fasten the deck and deck roof to the house, for precautionary reasons it's recommended that lag screws be installed to at the marked locations to better fasten the deck and deck roof to the house. The deck posts at the bottom of the side deck steps are loose, a cracked step tread was also noted, The gate at the top of the side deck steps has loose and warped balustrades. The under deck access doors bottom hinge is not fastened to the frame.

2. Deck: Pressure Treated Lumber - Due to age of deck and construction methods of the time, nails were used to fasten the deck and deck roof to the house, for precautionary reasons it's recommended that lag screws be installed to at the marked locations to better fasten the deck and deck roof to the house. The deck posts at the bottom of the side deck steps are loose, a cracked step tread was also noted, The gate at the top of the side deck steps has loose and warped balustrades. The under deck access doors bottom hinge is not fastened to the frame.

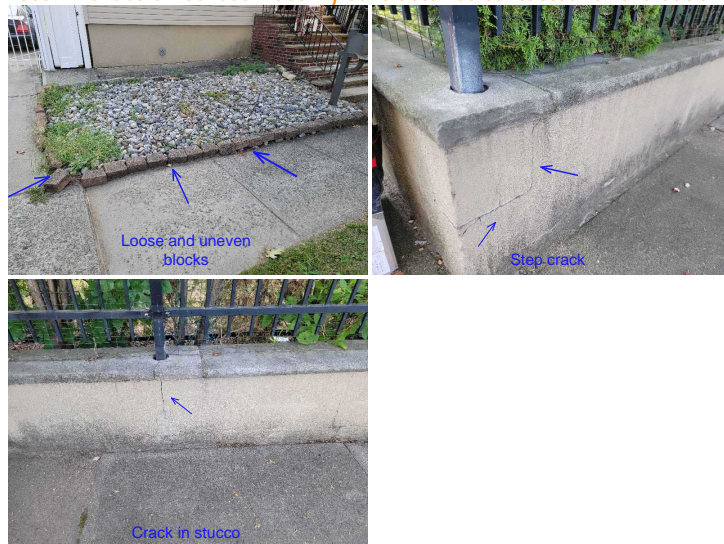
9. Functional, Monitor, Maintenance Item Retaining Walls: Concrete, Block - The block wall in front of the home was laying loosely and uneven. The stucco wall with fencing on top had a step crack in the corner as well as other cracks in the stucco. It's recommended a licensed Masonry contractor be contacted for evaluation.

3. Retaining Walls: Concrete, Block - The block wall in front of the home was laying loosely and uneven. The stucco wall with fencing on top had a step crack in the corner as well as other cracks in the stucco. It's recommended a licensed Masonry contractor be contacted for evaluation.

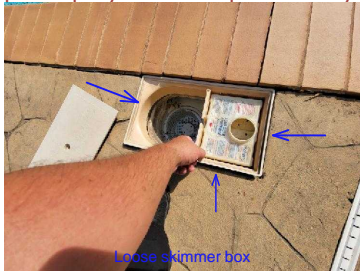
7. Functional, Defective Skimmer: Main drain screen, Strainer basket, Weir - While inspecting the pool skimmer, it was noted that upper half of the skimmer box was loose and lifted off the lower half, which is permanently affixed to the pool. It's recommended that a water proof epoxy be used to permanently reattach the upper half of the skimmer box to the lower half.

3. Behind home Swimming Pool Skimmer: Main drain screen, Strainer basket, Weir - While inspecting the pool skimmer, it was noted that upper half of the skimmer box was loose and lifted off the lower half, which is permanently affixed to the pool. It's recommended that a water proof epoxy be used to permanently reattach the upper half of the skimmer box to the lower half.

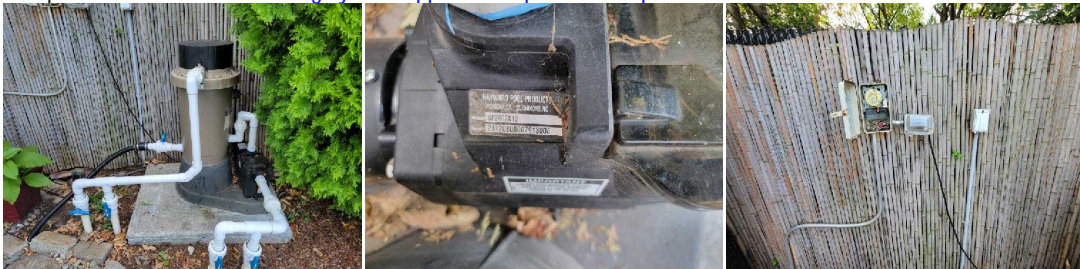
Pump Motor: 1 HP - Pool filtering system appears to operate on a pre-set timer.

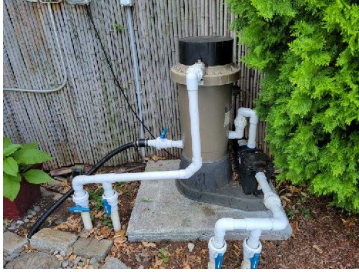
9. Functional Filter: Hayward, Diatomaceous earth filter

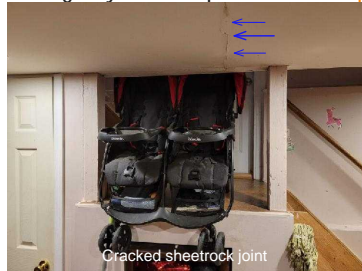
1. Functional, Monitor Unable to Inspect: 30% - Due to wall, ceiling, and floor finishes, as well as furnishings and storage, the Inspector was unable to fully inspect the basement due to inaccessibility. It's recommended that when the location is empty the client perform a minor visual check of the area.
2. Functional, Maintenance Item Ceiling: Drywall and paint - Cracks present at a joint in the sheetrock. Recommend repair by a licensed contractor.

4. Main Basement Ceiling: Drywall and paint - Cracks present at a joint in the sheetrock. Recommend repair by a licensed contractor.

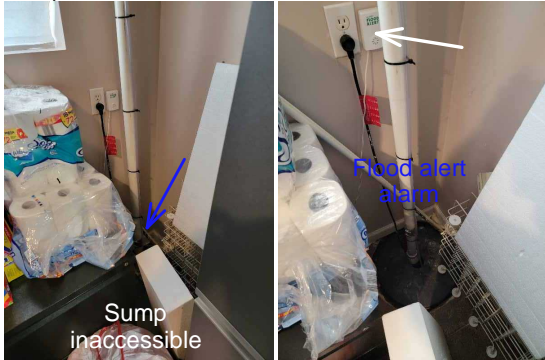
12. Functional Vapor Barrier: Paper
13. Functional Ventilation: Windows
14. Not Inspected Sump Pump: Front corner of workshop - The Inspector was unable to inspect the sump pump and sump pit due to the storing of personal items that prevented access to them. Recommend a licensed Plumbing contractor be contacted for an evaluation.

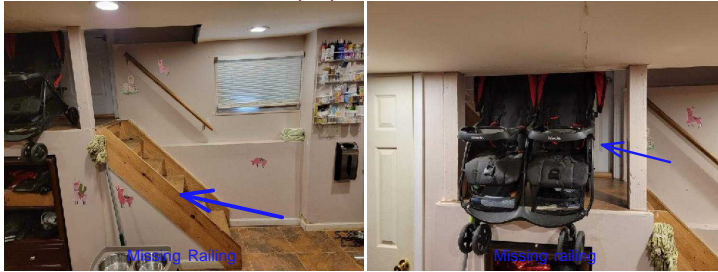
16. Functional, Hazardous Basement Stairs/Railings: Wood stairs with wood handrails - It was observed that one side of the basement stairs is open and has no handrail. This is a condition where a person could fall off of the steps. It's recommended that a licensed contractor be contacted for installation of a proper handrail.

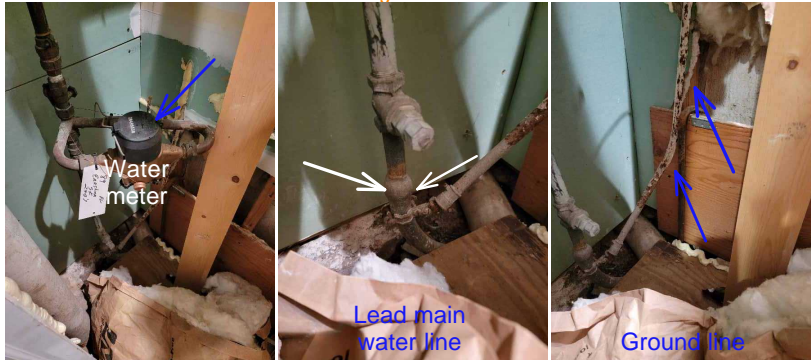
1. Functional, Marginal Main Service Line: Lead - The inspection of the main water line into the home revealed that it may be made of lead. It's recommended that a licensed Plumbing contractor be contacted for an evaluation.

9. Main Service Line: Lead - The inspection of the main water line into the home revealed that it may be made of lead. It's recommended that a licensed Plumbing contractor be contacted for an evaluation.

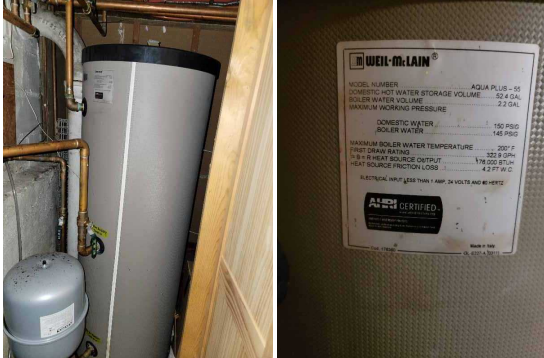
9. Manufacturer: Weil-McLain

10. Model Number: AQUAPLUS-55 Serial Number: No serial number was visible

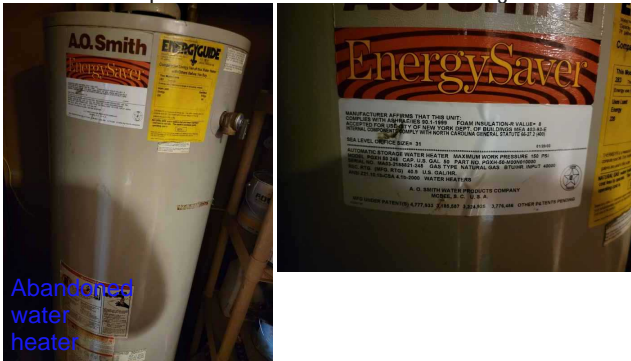
15. Defective Water Heater Operation: Abandoned/Non functioning

6. Basement, Utility Room Water Heater Water Heater Operation: Abandoned/Non functioning

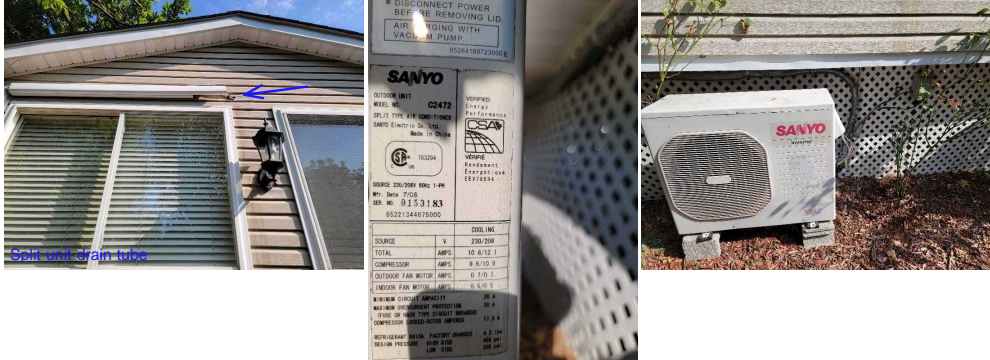
2. Functional, Marginal Condensate Removal: PVC - The condensate drain lets the water run down the siding and against a window. It's recommended that the drain line be extended to divert the condensate water off of siding and away from the window.

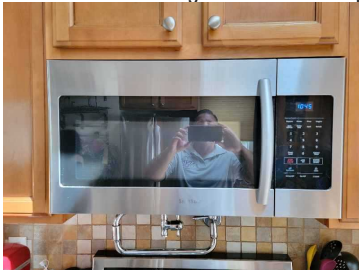
Ventilator: Samsung - At time of inspection the unit is a self venting unit that recirculates into kitchen

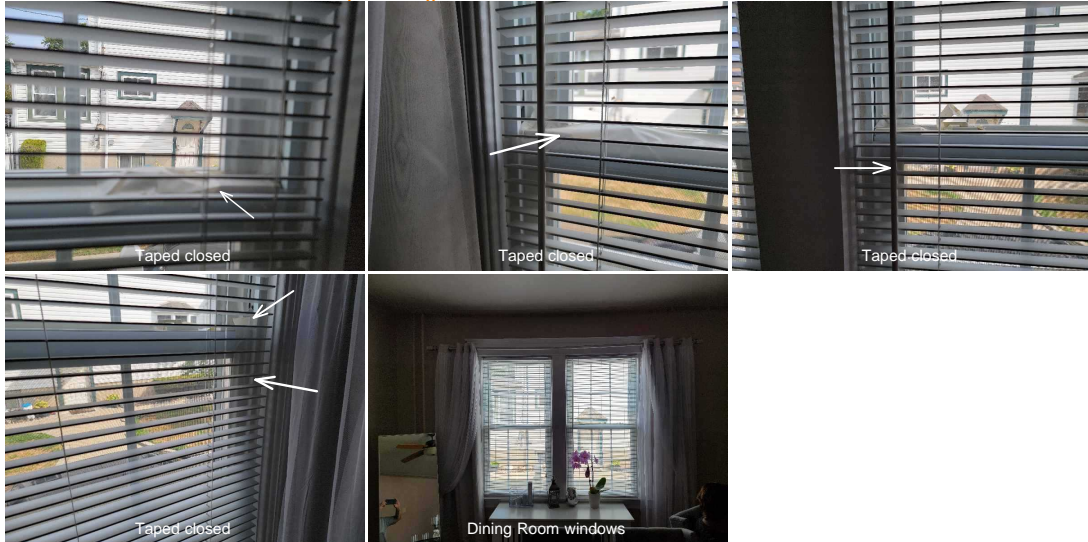
13. Functional, Marginal Windows: Vinyl double hung - Both windows in the Dining Room were taped closed and unable to be unlocked or opened. This may be an indication of the weather strips failing. It's recommended that a licensed contractor be contacted for further evaluation.

11. Dining Room Living Space Windows: Vinyl double hung - Both windows in the Dining Room were taped closed and unable to be unlocked or opened. This may be an indication of the weather strips failing. It's recommended that a licensed contractor be contacted for further evaluation.

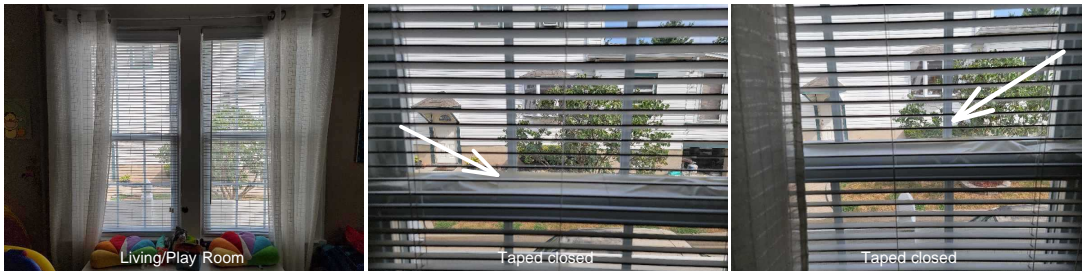
22. Functional Windows: Vinyl double hung - Two of the three windows located in the Living/Play Room were taped closed and unable to be unlocked or opened. This may be an indication of the weather strips failing. It's recommended that a licensed contractor be contacted for further evaluation.

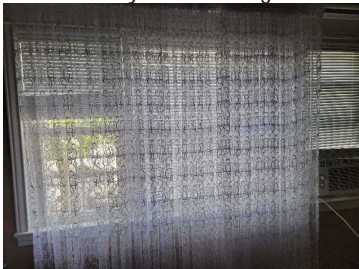
- 28. Functional Walls: Drywall and paint
- 29. Functional Floor: Hardwood
- 30. Functional Ceiling: Drywall and paint
- 31. Functional Windows: Vinyl double hung - *The left window won't stay open. Recommend a licensed contractor be contacted to evaluate.*

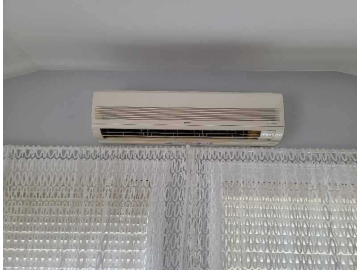
44. Functional, Marginal HVAC Source: Mini-Split unit for Air Conditioning, in floor radiant heatin, freestanding gas fireplace

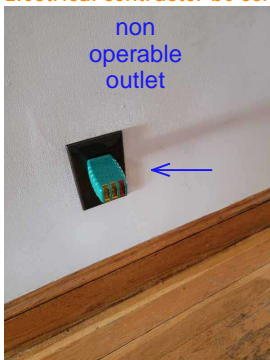
52. Functional, Defective Electrical: 110 VAC outlets and lighting circuits - **The outlet located in the 1st floor hall was not working. Recommend a licensed Electrical contractor be contacted for further evaluation and repair**

7. 1st Floor Hall Living Space Electrical: 110 VAC outlets and lighting circuits - The outlet located in the 1st floor hall was not working. Recommend a licensed Electrical contractor be contacted for further evaluation and repair

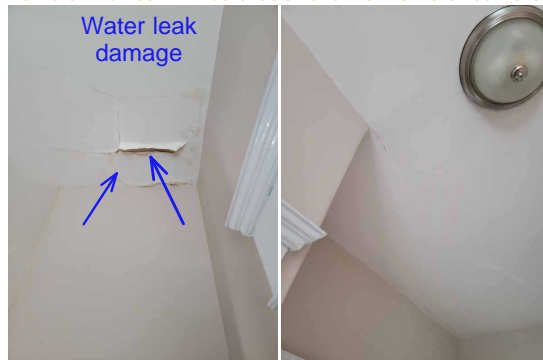
- 64. Functional Walls: Drywall and paint
- 65. Functional Floor: Hardwood
- 66. Functional, Maintenance Item Ceiling: Drywall and paint - **The ceiling on the 2nd floor hall has an area that has water damage from a prior leak. The home owner confirmed that this is from an old leak that was repaired.**

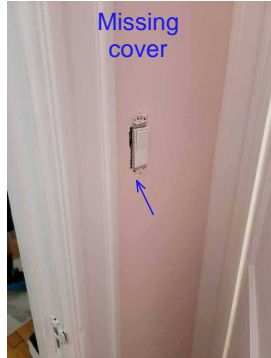
25. Functional, Maintenance Item Electrical: 110 VAC outlets and lighting circuits - Light switch was missing a cover. recommend cover be installed

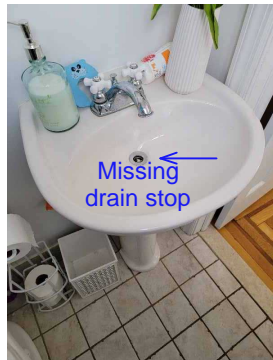
- 9. Functional HVAC Source: Radiant in floor heating
- 10. Functional Counter/Cabinet: None
- 11. Functional, Maintenance Item Sink/Basin: Pedestal - Sink drain stop missing. Replacement recommended.

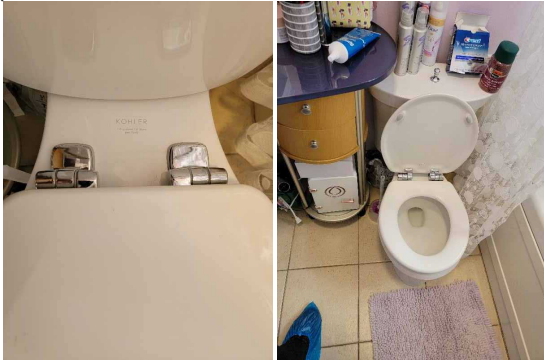
28. Functional, Not Inspected Tub/Shower Surround: Fiberglass tub with spa jets and tile surround - Due to items stored in tub the Inspector was unable to fill tub enough to ascertain if the spa jets operate. Recommend a licensed Plumbing contractor be contacted for evaluation.

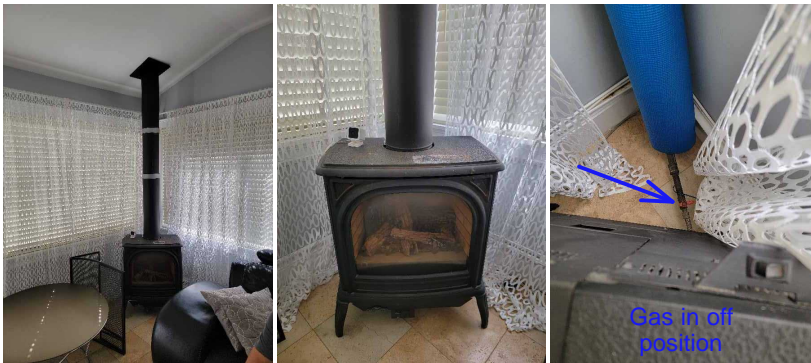
1. Not Inspected Freestanding Stove: Natural gas - The freestanding, gas operated, fireplace appliance, located in the Family Room, appears to be a sealed non opening unit. The Flue, body, glass front, insert walls, and ceramic logs all appear to be in a clean and functional condition, but the Inspector was unable to operate it due to the gas line that supplies it being off. It's recommended that a licensed contractor be contacted for an evaluation.

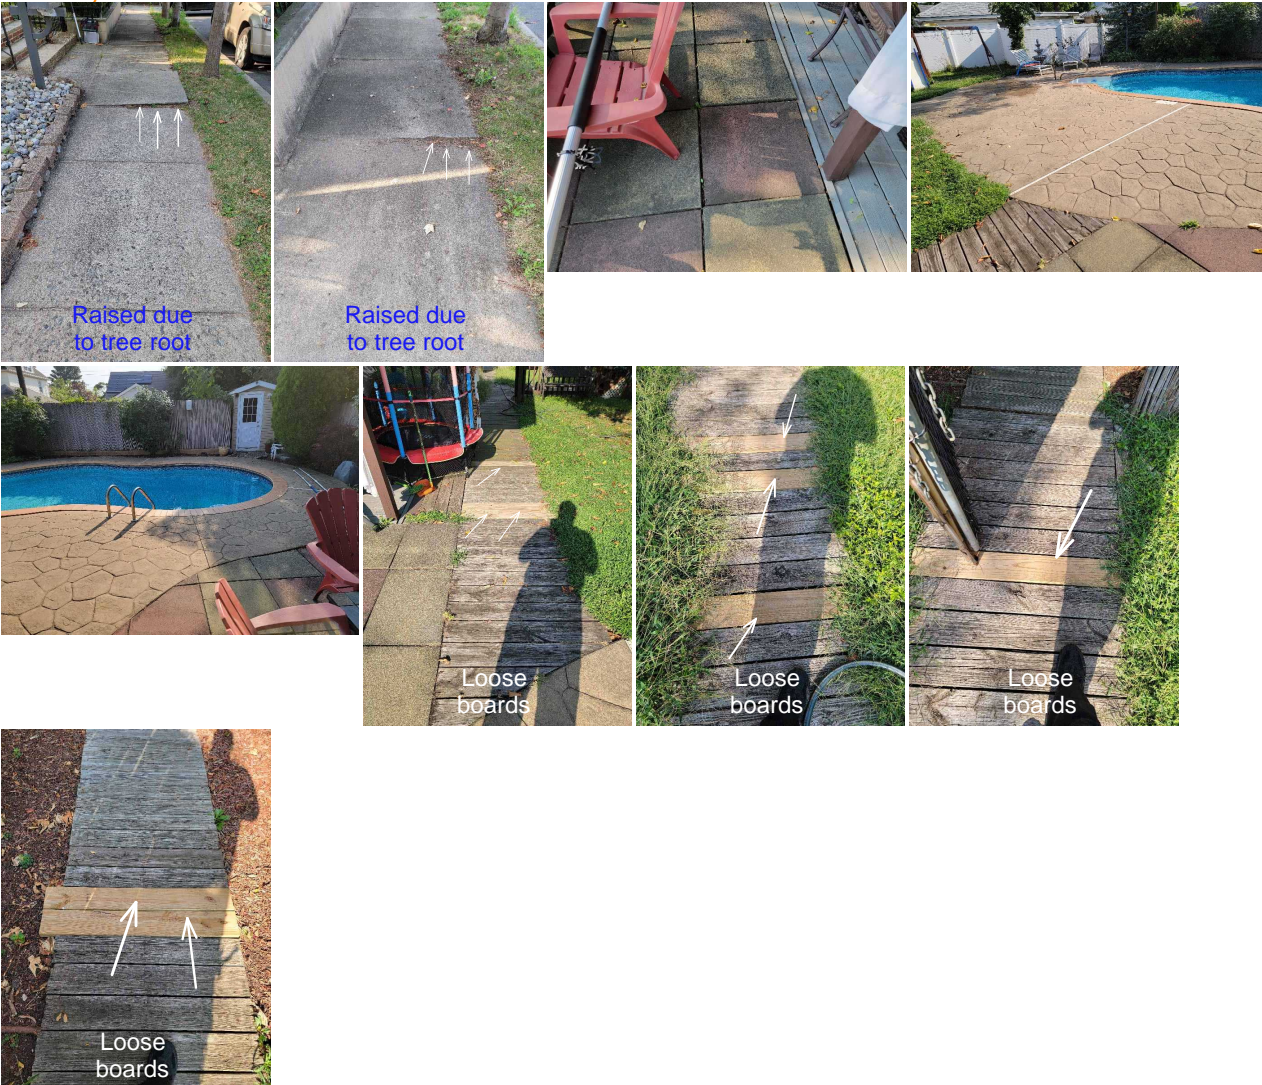
5. Walks: Concrete, Wood, Patio Block - Two front walkway slabs were observed lifting, possibly due to tree roots. This can cause a trip/fall hazard. Recommend a licensed Masonry contractor be contacted for evaluation/repair. It's also recommended that all loose wooden walkway boards be securely screwed down.

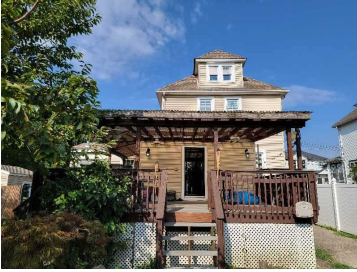
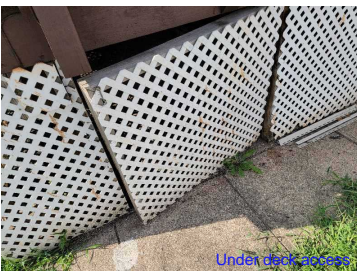
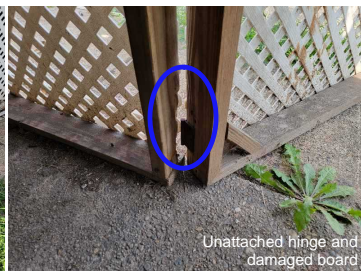
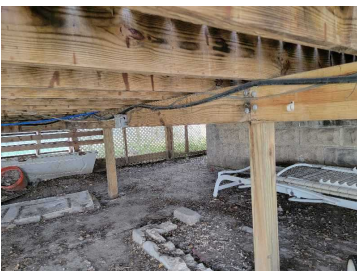
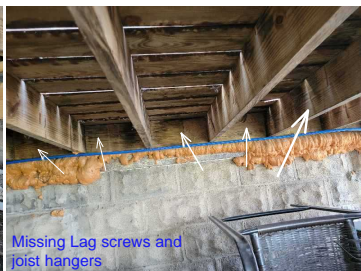
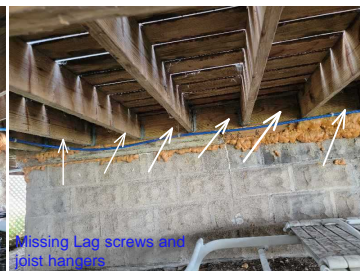
6. Deck: Pressure Treated Lumber - Due to age of deck and construction methods of the time, nails were used to fasten the deck and deck roof to the house, for precautionary reasons it's recommended that lag screws be installed to at the marked locations to better fasten the deck and deck roof to the house. The deck posts at the bottom of the side deck steps are loose, a cracked step tread was also noted, The gate at the top of the side deck

steps has loose and warped balustrades. The under deck access doors bottom hinge is not fastened to the frame.

2. Deck: Pressure Treated Lumber - Due to age of deck and construction methods of the time, nails were used to fasten the deck and deck roof to the house, for precautionary reasons it's recommended that lag screws be installed to at the marked locations to better fasten the deck and deck roof to the house. The deck posts at the bottom of the side deck steps are loose, a cracked step tread was also noted, The gate at the top of the side deck steps has loose and warped balustrades. The under deck access doors bottom hinge is not fastened to the frame.

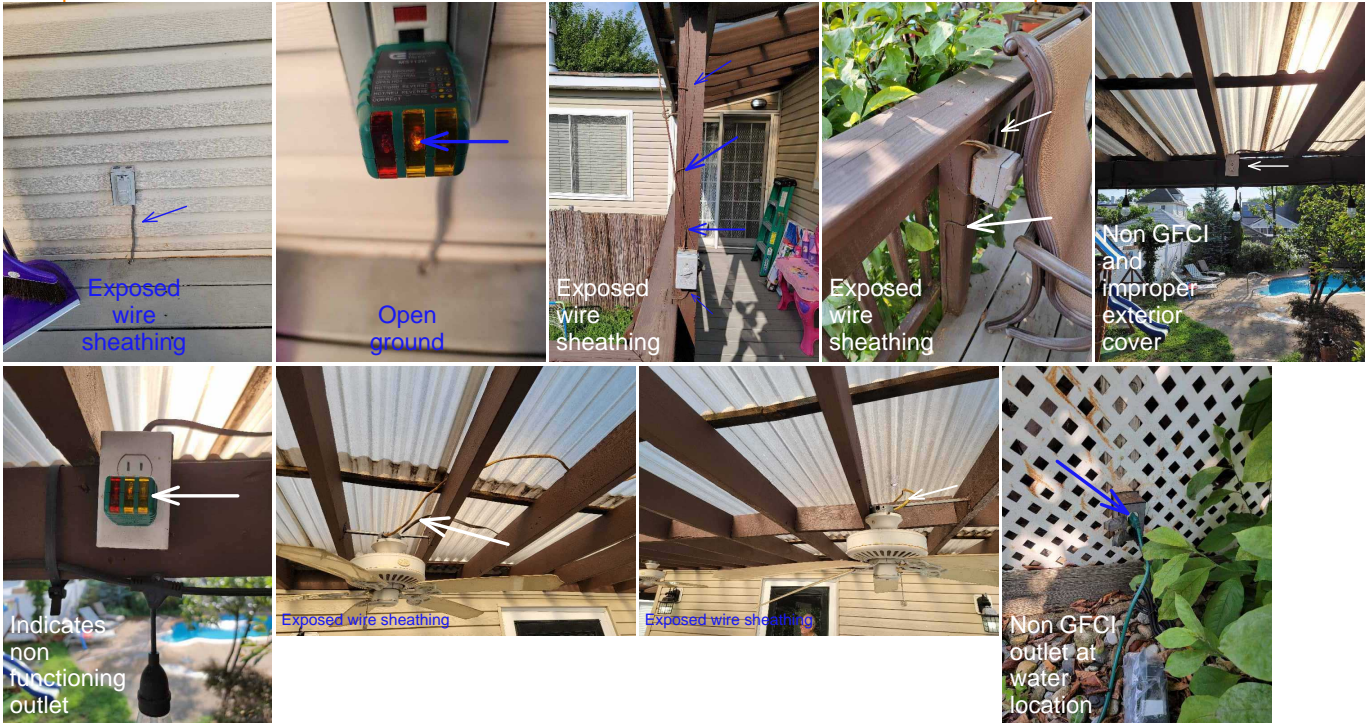
7. Exterior Outlets 110 VAC Non-GFCI, 110 VAC GFCI - The covered rear deck has electrical outlets and lighting. Most of the wiring to these outlets and lights has exposed sheathing that is not properly installed in exterior rated conduit. The GFCI located on the deck has an open ground. There outlet located on ceiling of deck that was inoperable and does not have a proper weather covering. The outlet located on deck skirting, that is within 6 feet of a pond is a non GFCI. It's recommended that a licensed Electrician be contacted for evaluation and repairs

4. Exterior Outlets 110 VAC Non-GFCI, 110 VAC GFCI - The covered rear deck has electrical outlets and lighting. Most of the wiring to these outlets and lights has exposed sheathing that is not properly installed in exterior rated conduit. The GFCI located on the deck has an open ground. There outlet located on ceiling of deck that was inoperable and does not have a proper weather covering. The outlet located on deck skirting, that is within 6 feet of a pond is a non GFCI. It's recommended that a licensed Electrician be contacted for evaluation and repairs

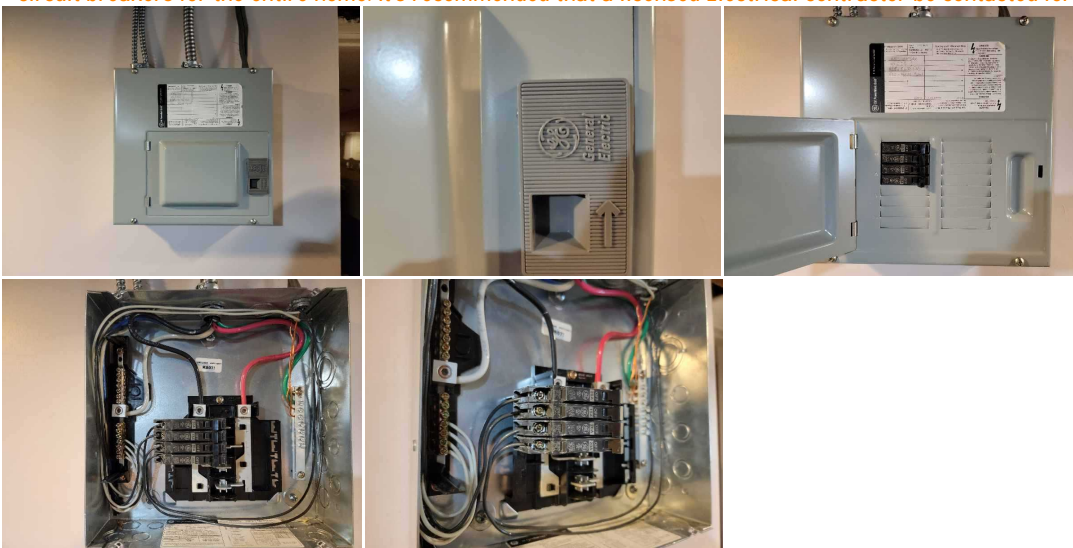
8. Basement Electric Panel Manufacturer: General Electric - During the inspection this was the only electric panel found inside of home and a conversation with the homeowner confirmed this. It appears to be undersized for today's electrical needs of a modern home, as well as only having 4 circuit breakers for the entire home. It's recommended that a licensed Electrical contractor be contacted for a further evaluation.

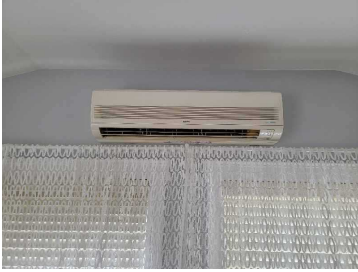
13. Family Room Living Space HVAC Source: Mini-Split unit for Air Conditioning, in floor radiant heatin, freestanding gas fireplace

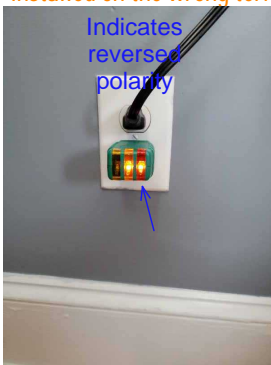
14. Master Bedroom Electrical: 110 VAC outlets and lighting circuits - Outlet wires are Reversed polarity, meaning the white and black wires were installed on the wrong terminals on the outlet.

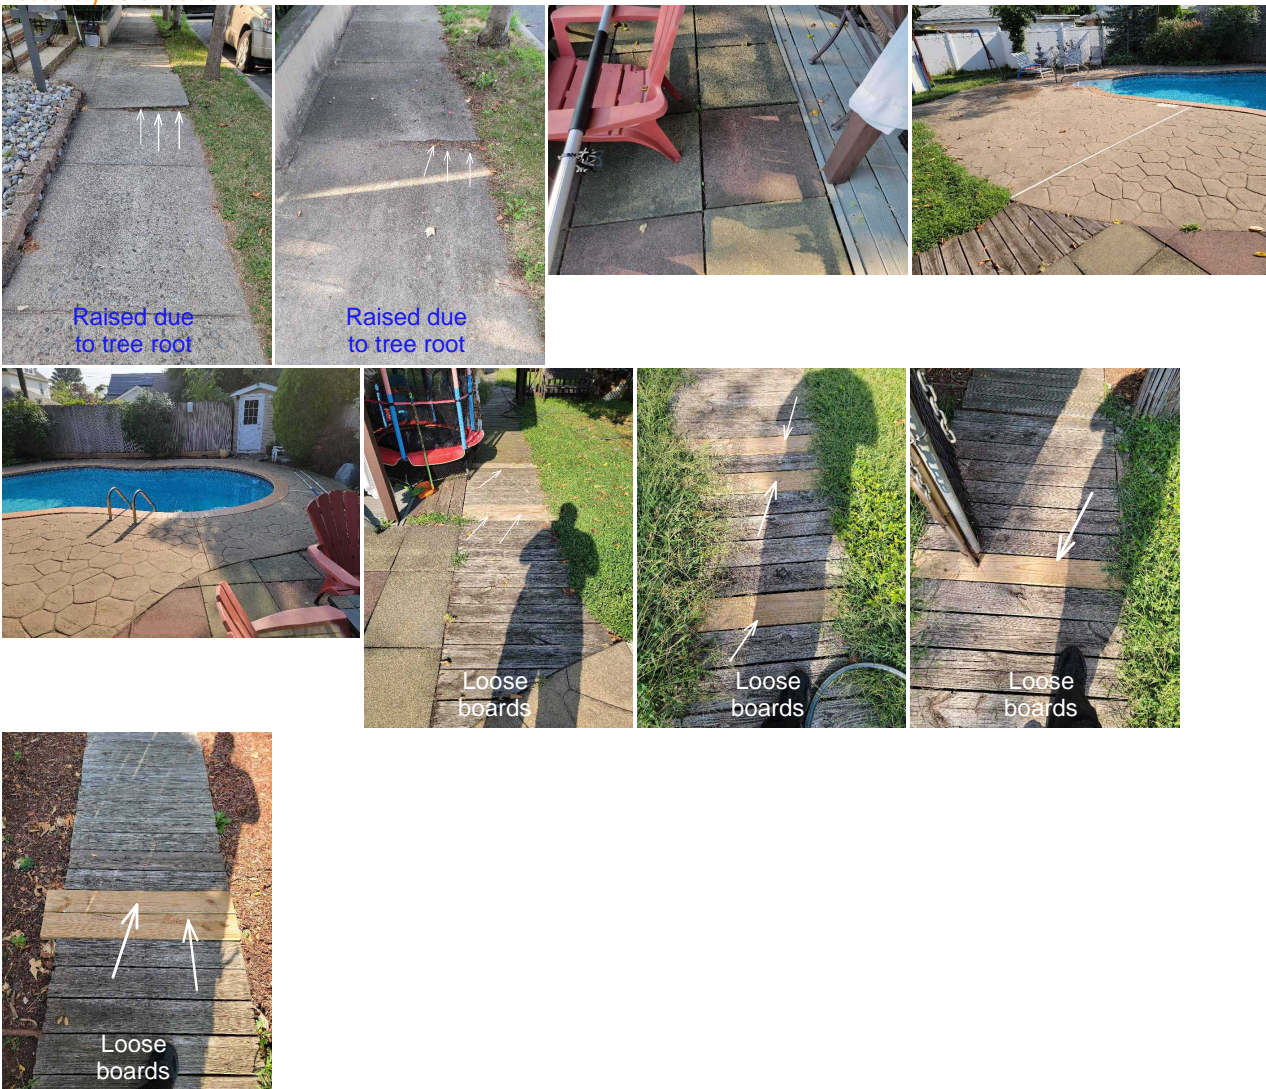
4. Walks: Concrete, Wood, Patio Block - Two front walkway slabs were observed lifting, possibly due to tree roots. This can cause a trip/fall hazard. Recommend a licensed Masonry contractor be contacted for evaluation/repair. It's also recommended that all loose wooden walkway boards be securely screwed down.

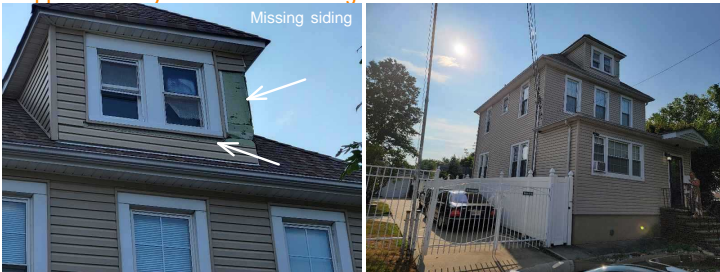
1. 1st Floor, 2nd Floor, dormer Exterior Surface Type: Vinyl siding - During the inspection it was noted that the right corner of the attic dormer is missing approximately 4 sections of siding. It's recommended that a licensed contractor be contacted for repair/replacement of those missing sections.

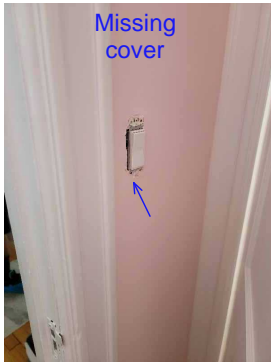
6. Rear Bedroom Electrical: 110 VAC outlets and lighting circuits - Light switch was missing a cover. recommend cover be installed

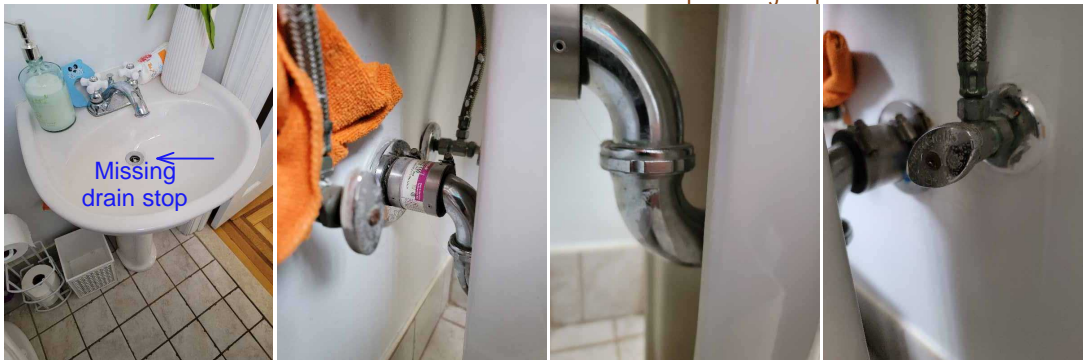
7. 1st floor 3/4 Bathroom Bathroom Sink/Basin: Pedestal - Sink drain stop missing. Replacement recommended.

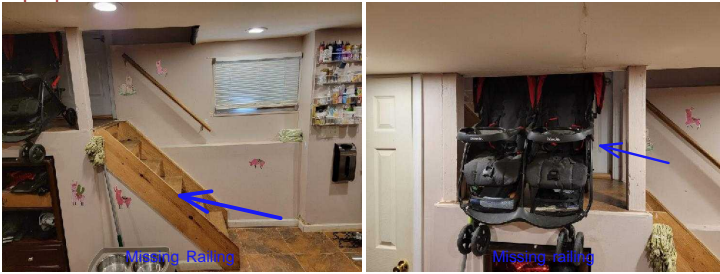
1. Main Basement Basement Stairs/Railings: Wood stairs with wood handrails - It was observed that one side of the basement stairs is open and has no handrail. This is a condition where a person could fall off of the steps. It's recommended that a licensed contractor be contacted for installation of a proper handrail.
